UNDERWATER BRIDGE INSPECTION REPORT

STRUCTURE NO. 58520

KETTLE RIVER

DISTRICT 1 - PINE COUNTY

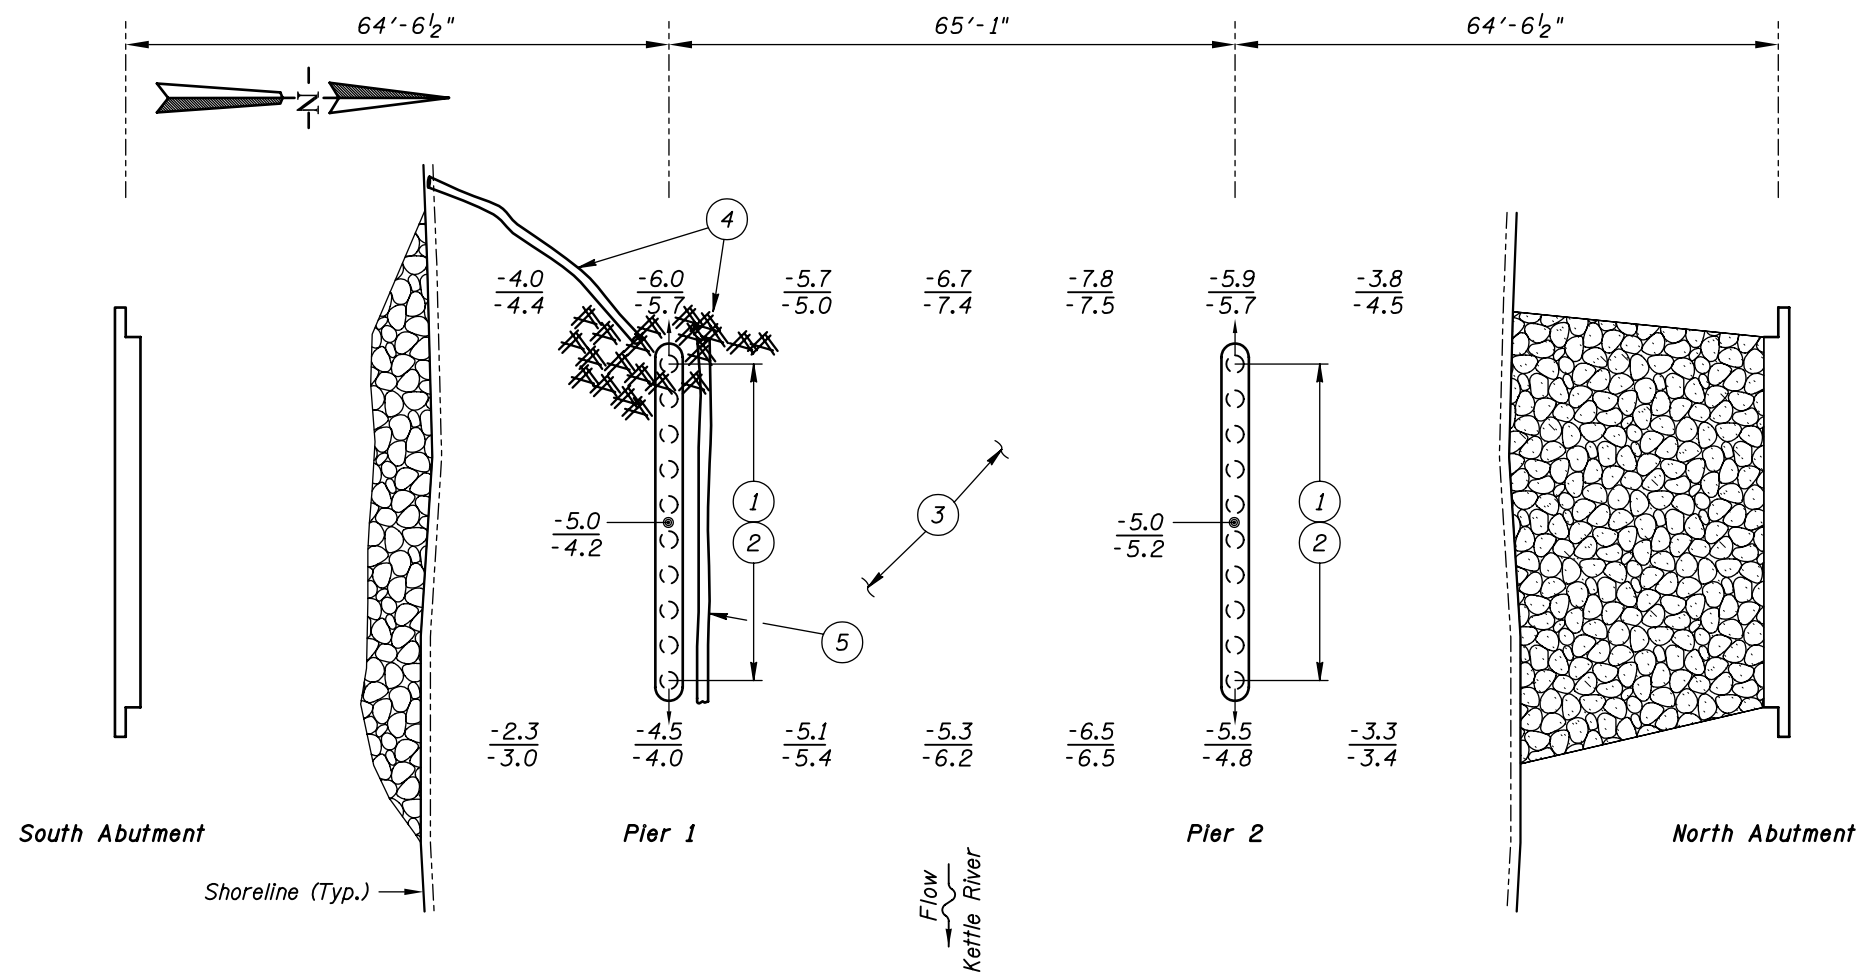
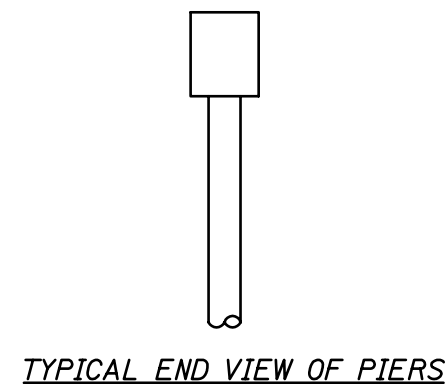
INSPECTION AND SOUNDING PLAN

- The steel piles exhibited coating failure on 80 to 100 percent of the surface area from 3 feet above the waterline to the channel bottom.
- The steel piles exhibited light surface corrosion with rust nodules and up to 1/16 inch of pitting on 50 percent of the surface area from 3 feet above the waterline to the channel bottom.
- The channel bottom material consisted of sandy gravel and approximately 4-inch-diameter cobbles with up to 1 foot probe rod penetration.
- A moderate accumulation of timber debris, including a 12-inch-diameter tree, was observed at the upstream end of Pier 1.
- An 18-inch-diameter tree was observed along the north side of Pier 1.

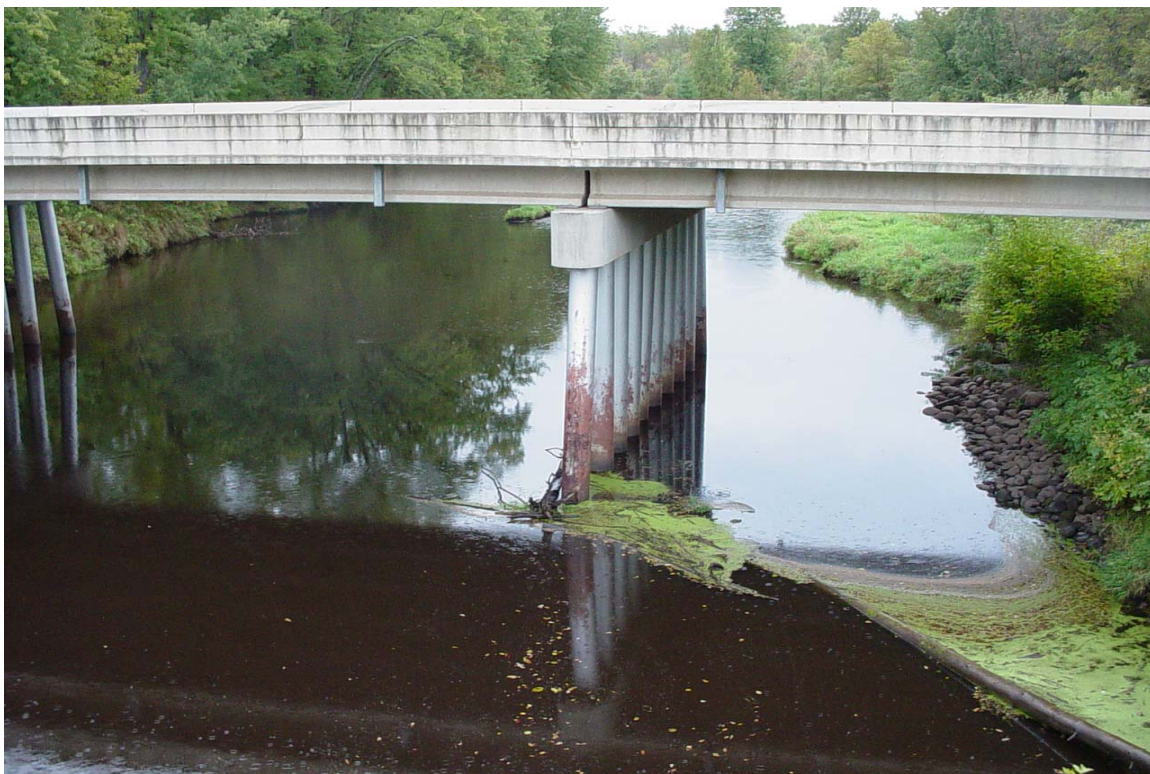
Photograph 2. View of Pier 1, Looking East.

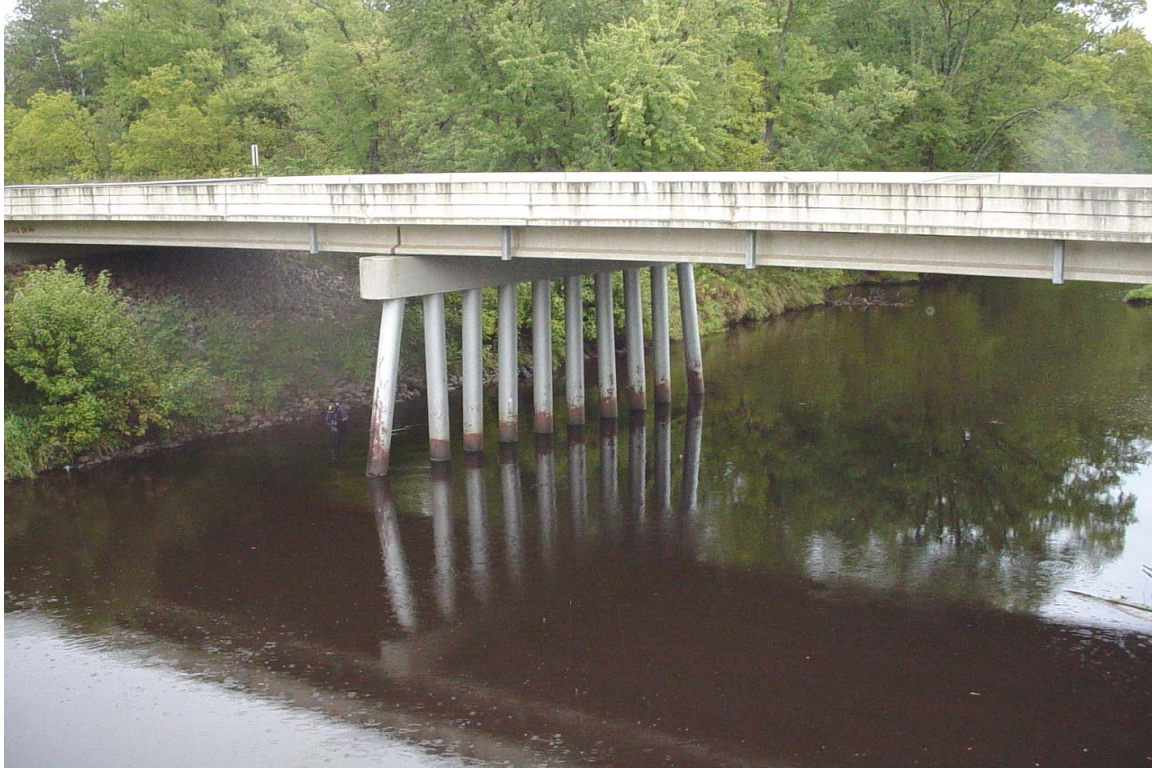
Photograph 3. View of Pier 2, Looking Northeast.

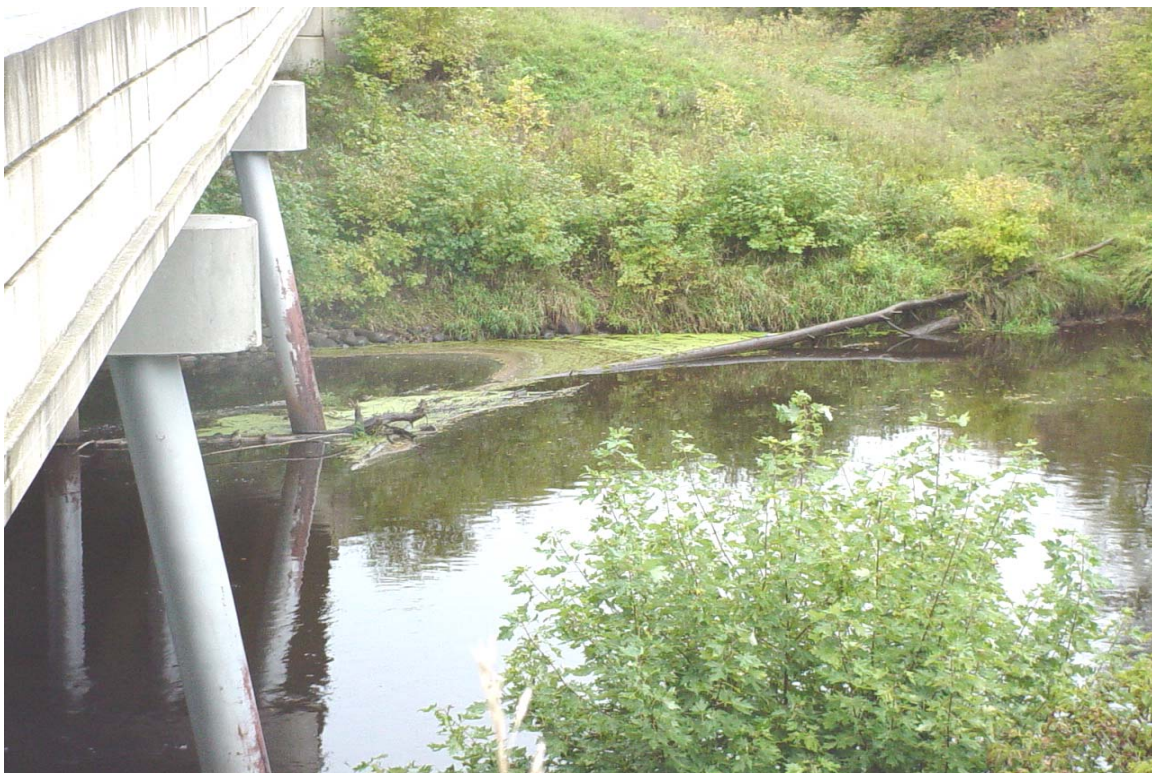
- (A) The steel piles exhibited coating failure on 80 to 100 percent of the surface area, and light surface corrosion with rust nodules and up to 1/16 inch deep pitting on 50 percent of the surface area, from 3 feet above the waterline to the channel bottom.
- (B) A moderate accumulation of timber debris, including a 12-inch-diameter tree, was observed at the upstream end of Pier 1, and an 18-inch-diameter tree was observed extending along the north side of Pier 1.

Photograph 4. View of Timber Debris at the Upstream Nose of Pier 1, Looking South.

- (A) Reinspect the submerged substructure units at the normal maximum recommended (NBIS) interval of five (5) years. Monitor the drift accumulation at Pier 1 during future inspections.
